When Things Do Not Go as Planned: Restorative Reconstruction Concepts to Solve a Surgical Dilemma

Written by Mary Frances Riley, DDS
Saturday, 01 March 2008 00:00

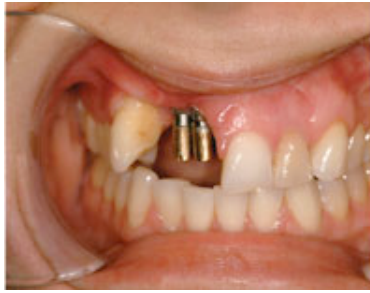
Figure 3. Preoperative view with existing root form implants.

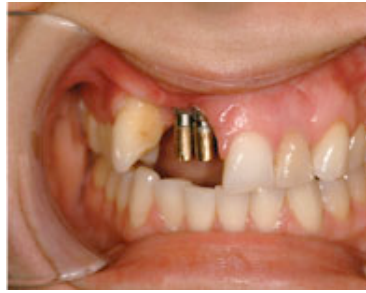
Figure 4. Severe root exposure of tooth No. 6.

I planned to do direct bonded resin veneers on teeth Nos. 4, 5, 12, and 13 and porcelain laminate veneers on teeth Nos. 9 and 11. I utilized pink porcelain to simulate the gingiva that was missing. A zirconia crown was planned for tooth No. 10, and a porcelain-to-noble-gold crown was planned for tooth No. 6. One final consideration was replacing the

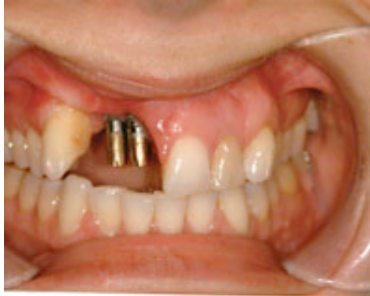
Figure 5. Tooth No. 10 discolored from previous root canal treatment.

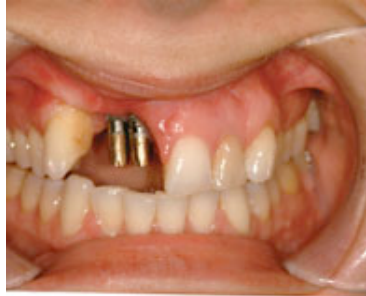
Figure 6. Overview demonstrating closely aligned implants replacing teeth Nos. 7 and 8.

Examination showed that the 2 implants replacing teeth Nos. 7 and 8 had drifted, and the surrounding tissue was not aesthetically pleasing (Figure 6). The alignment of the implants presented a challenge due to the angulation and close proximity to each other. The tissue around the implants was also not aesthetically acceptable due to lack of attachment.

One possible method to correct this could have been more surgery. Grafting could be done to improve tissue aesthetics. The implants could be redone to improve the angulation. Having already been through multiple surgeries, the patient was not receptive to either of the two possibilities. The patient's wishes were taken into consideration in the evaluation of her case for treatment modalities.

Radiographs of the implants revealed that they were indeed fully integrated, in spite of some of the cervical threads being exposed. The rest of the teeth in her smile line were functionally healthy, so I decided to handle the case restoratively.

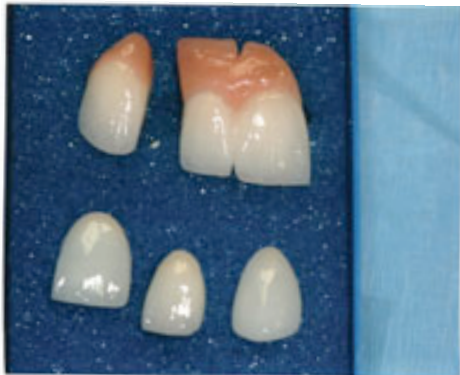
Figure 7. Teeth Nos. 6 to 8: porcelain-to-gold crowns. Teeth Nos. 9 and 11: porcelain laminate veneers. Tooth No. 10: zirconia crown.

flipper. After discussions with the patient I decided to do porcelain crowns along with pink porcelain to replace the large area of missing gingiva. I would join them together to stabilize the implants and also allow slight room between the porcelain and the mucosa (Figures 7 and 8). Since hygiene can be an issue around implants, this would allow the patient to floss under the pontics, which is very important for the longevity of the case (Figure 9).

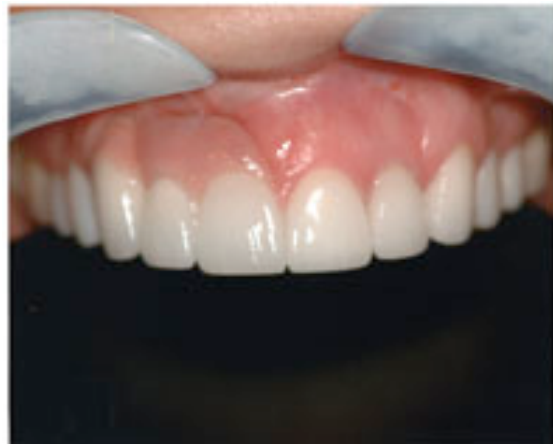
Figure 8. Figure 7 restorations placed in addition to direct bonded composite veneers on tooth Nos. 4, 5, 12, and 13.

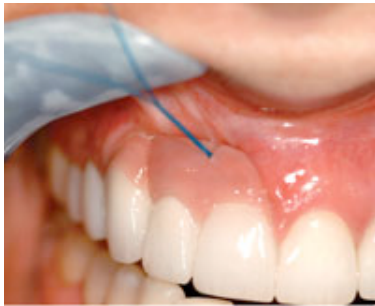
Figure 9. Floss threader that easily passes between teeth Nos. 7 and 8.

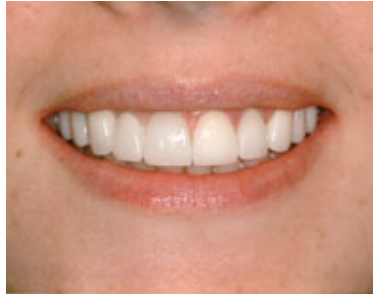
Figure 10. Virtual gingival line.

I performed the restorative work with standard procedures, with the exception of the pink porcelain. In order to achieve a cosmetically and functionally acceptable outcome, a lot of thought was put into the placement of the “virtual gingival line” (Figure 10). Temporaries were fabricated to simulate the final restorations to give the patient time to evaluate the potential outcome. Once the patient accepted the temporaries, it was only a matter of having the laboratory fabricate the final restorations using my established guidelines (Figures 11 to 14).
